Scientific
Journal of
**Applied
Social and
Clinical
Science**

**PEDESTRIAN
ACCESSIBILITY OF THE
CENTRAL AISLE OF THE
CITY OF TAQUARITINGA,
SP, BRAZIL**

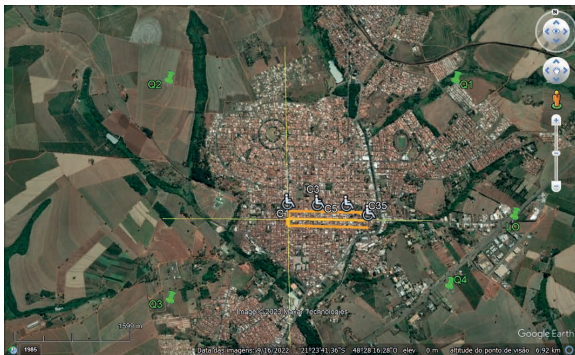
Figure 3. Map of the urban area of the city of Taquaritinga detailing the city’s quadrants.

To begin demarcating the urban area, it was necessary to divide it into 4 quadrants (Q1, Q2, Q3 and Q4) with north-south and east-west lines, forming a right angle (Figure 3). To carry out this practice, we used the tool on the top tab called “path”. Next, the “marker” tool was used to identify the quadrants of the district in an urbanized area. To demarcate the accessibility mapping area, the “polygon” tool was used, which allows you to accurately measure the perimeter and area, and for the construction of straight or winding lines, the “path” tool was used, and with this issue, the map is manually constructed.

Source: Prepared by the authors (2023); in yellow the North-South and East-West transects; in green the identification of the quadrants of the urban area; in orange the accessibility polygon in the central region of the city of Taquaritinga-SP

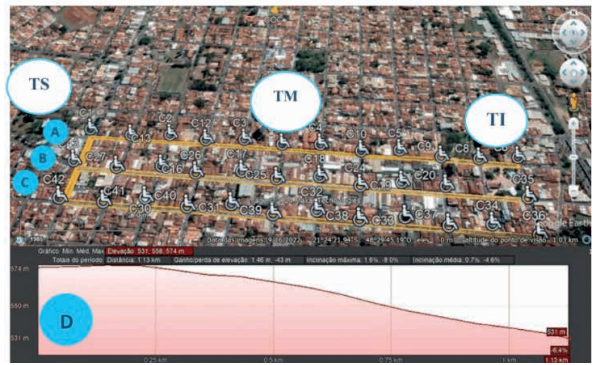
Figure 4. Longitudinal corridors of the urban area of the city of Taquaritinga-SP

The perimeter of the central aisle polygon is 7.1 km, while the respective area is 3.82 hectares. The three corridors make up 36 intersections between public roads in this study region, that is, 144 corners. The highest point of the corridors is 576 m above sea level (Figure 4), while the lowest area is 533 m above sea level. The slope of the roads mentioned varies from 1.6% to 8.0%, and an average slope of the three corridors is 4.6%, with an average length of each corridor of 1.13 km.

Source: Prepared by the authors (2023); in orange the central longitudinal corridors of the city of Taquaritinga-SP; in blue “A” identifies the corridor relating to Rua Campos Sales; in blue “B” identifies the corridor relating to the central street Prudente de Moraes; in blue “C” identifies the corridor relating to Rua Treze de Maio in the city of Taquaritinga-SP; in blue “D” shows the profile cut and ground elevation; TS: upper third of the corridor; TM: middle third of the corridor; IT: lower third of the corridor

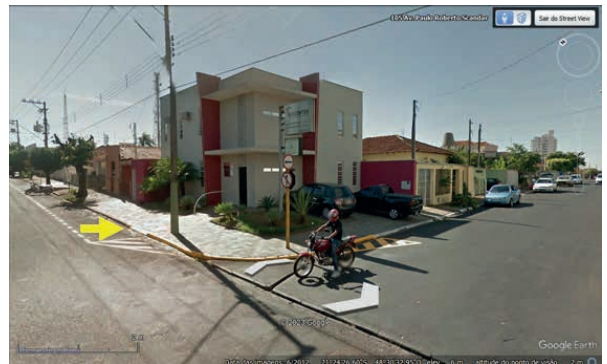
Figure 5. View of one of the corners of Av. Paulo Roberto Scander, upper part of the accessibility corridor in the city of Taquaritinga-SP

At the third assessment point, the upper part of the central aisle, it is noted that there is only a modest access ramp just facilitating access to the commercial house, with no such adjustments being made on other corners

Source: organized by the authors (2023); Yellow arrow indicating a modest access ramp for detained people.

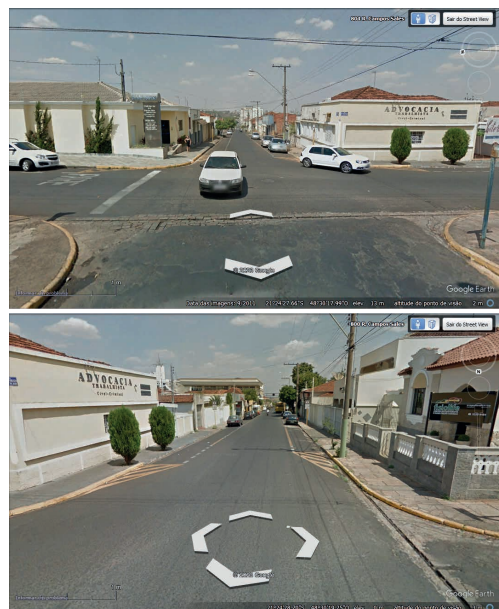
Figure 6. View of two corners of Rua Campos Sales, upper part of the accessibility aisle in the city of Taquaritinga-SP.

It can be seen, in Figure 6, that there is no access ramp for wheelchair users and very reduced ground signage and sidewalks with modest width.

Source: organized by the authors (2023); Yellow arrow indicating a modest access ramp for detained people

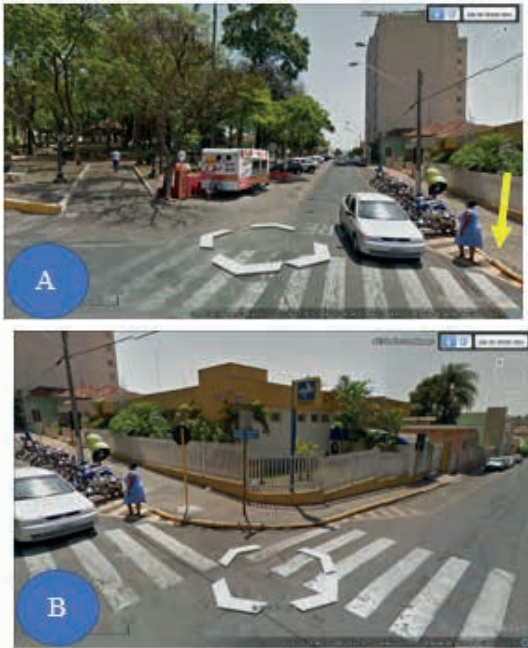
Figure 7. View of two corners of Rua dos Domingues, lower part of the accessibility corridor aisle in the city of Taquaritinga — SP.
Source: organized by the authors (2023); Yellow arrow indicating a modest access ramp for detained people

In Figure 7, in A and B, there is a contrast that is quite common on public roads. One side has a modest access ramp (Yellow Arrow-A) and in the same space there must be other ramps to allow adequate movement of confined people. It is worth noting that ground signs seem to be more intense in the central region of the city.

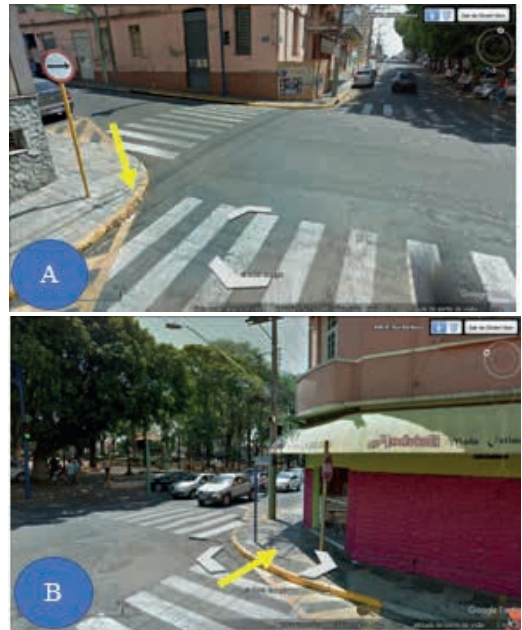
Figure 8. View of two corners of Rua Rui Barbosa, lower part of the accessibility corridor aisle in the city of Taquaritinga — SP.

In Figure 8, central region and close to the city's City Hall, something very common on public roads in Taquaritinga is observed, the presence of obstacles that hinder the movement of confined people (yellow arrow in B). Note also the absence of access ramps (yellow arrow in A) in a region with intense pedestrian movement, less than 200 meters from the city administration headquarters (City Hall) and the City Council.

NBR 9050:2020 very clearly highlights the concern with furniture on the accessible route

for trapped people or pedestrians. Furniture with a height between 0.60 m and 2.10 m from the floor may pose risks to people with visual impairments, if they have projections more than 0.10 m deep.

Source: organized by the authors (2023); Yellow arrow indicating a modest access ramp for detained people

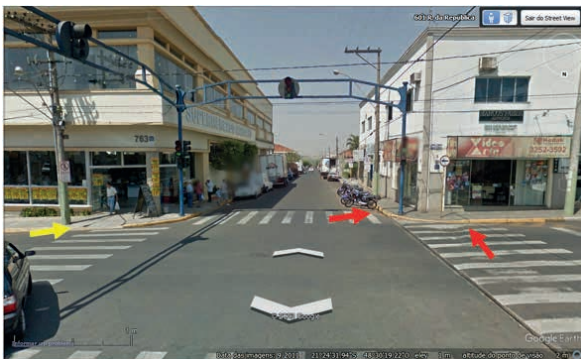
Figure 9. View of two corners of Rua da República, middle part of the accessibility corridor aisle in the city of Taquaritinga — SP.

In Figure 9, the middle region of the Taquaritinga accessibility corridor, there is good signage on the ground, however, a clear and very common inconsistency: an access ramp for restricted people (yellow arrow) and on the opposite side of access at the intersection, the absence access ramp for detained people (red arrows). Situations like these observed in the city of Taquaritinga were also corroborated by Godoy *et al.* (2023), in a city with a smaller number of inhabitants (Dobrada-SP), where both in the central region of the city and in the neighborhood region, there was no infrastructure for accessibility ramps for people with physical disabilities or reduced mobility.

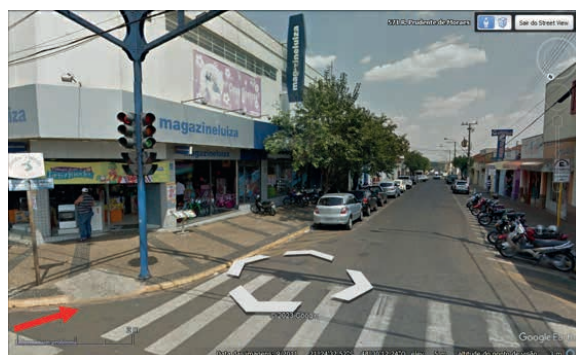
Figure 10. View of two corners of Rua da República, middle part of the accessibility corridor aisle in the city of Taquaritinga — SP.

It can be seen in Figure 10 and Figure 11, the middle part of the central accessibility corridor of Taquaritinga, the presence of an access ramp without proper signage as characterized by the standard. This fact is repeated at most intersections in the aforementioned corridor under study.

Source: organized by the authors (2023); Red arrow indicates accessibility ramp without painting indicating accessibility standard.

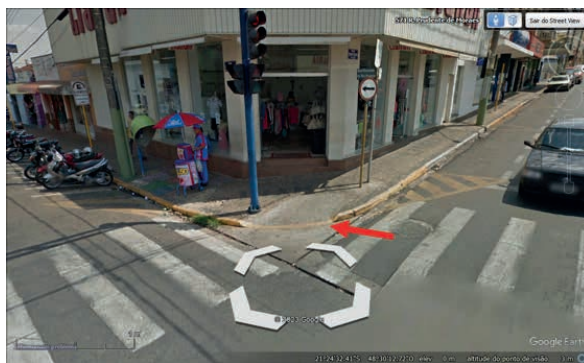
Figure 11. View of two corners of Rua São José, middle part of the accessibility corridor aisle in the city of Taquaritinga — SP.

It can be seen, in Figure 11, that the pedestrian space is divided with other urban elements, such as lighting posts, traffic signs and traffic lights, reducing the space for the movement of people with physical disabilities or reduced mobility, since the Pedestrian

space considers the movement of people, whether closed or not, in both directions.

Source: organized by the authors (2023); red arrow indicating accessibility ramp without indicative painting.

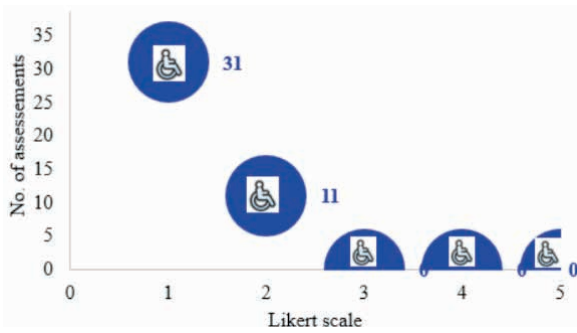
Graph 1. Conditions of the access ramps at the Commercial Center of Taquaritinga-SP
Source: Prepared by the authors (2023)

The survey of the visual quality conditions of the access ramps for people confined in the city of Taquaritinga-SP was evaluated at 44 points in the corridors, as shown in Graph 1. The evaluations were based visually according to data from Rodrigues and Chiconato (2023), where in such work the visual conditions of people isolated from a large part of Brazil were manifested. It is noted that the majority of intersections in the accessibility corridor proposed for the city of Taquaritinga-SP received an evaluation between poor (31) and regular (13). It is worth remembering that the “terrible” evaluation includes the absence of ramps, an insufficient number or poor construction quality.

It would be expected to have two ramps on each corner. What was actually observed is that in very few cases there was at most 1 ramp, on corners on the same side of the road, as shown in Figure 11, directing the movement of the trapped person in a diagonal direction and not in a straight direction with the ground signage. (Crosswalk).

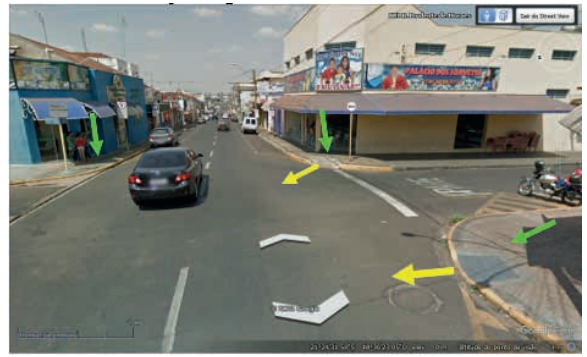
Figure 12. View of two corners of Rua São José, middle part of the accessibility corridor aisle in the city of Taquaritinga — SP.

Source: Prepared by the authors (2023); yellow arrow indicates the presence of an accessibility ramp without indicative painting; Green arrow indicates the type of coating called “Portuguese mosaic”.

coating called “Portuguese mosaic” in the region under study, followed by coating with straightened mortar (green arrows, Figure 12). The Portuguese mosaic, originating from 7 cm cubes of rocks in black (basalt, granite), white, yellow and pink. This sidewalk covering provides good traction for people who use wheelchairs. However, there are small bumps when walking on the covering, causing some discomfort for those trapped. Such observations were corroborated in the reports verified by Godoy *et al.* (2023).

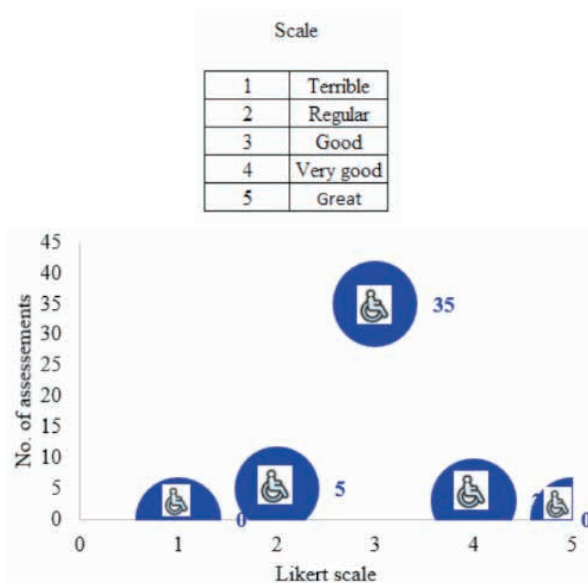
Graph 3. Most common defects on the sidewalks of accessibility to the Commercial Center of Taquaritinga-SP

When evaluating the most common defects in sidewalks, according to Rodrigues and Chiconato (2023), they found that the central sidewalks in the city of Taquaritinga-SP had a classification considered good (Graph 3). And what can still be seen is that there is a predominance of the type of sidewalk

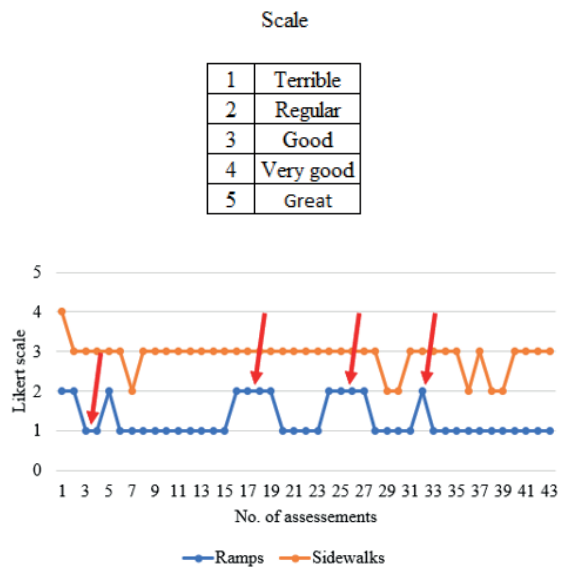
Graph 4. Relationship between ramp quality and hunting defects

In this work, it was also possible to verify the relationship between quality of ramps and defects in hunting, according to Rodrigues & Chiconato (2023). The points represented by the red arrows in Graph 4 seem to demonstrate that even though the quality of the access ramps for confined people was improved, the scale that represents the most common sidewalk defects was maintained, denoting an importance for confined people in relation to the most common defects. that interfere with the walkability of those with physical

Source: Prepared by the authors (2023); Red arrows indicate points that show independence of the variations that occurred in relation to the perception of the quality of the ramps.

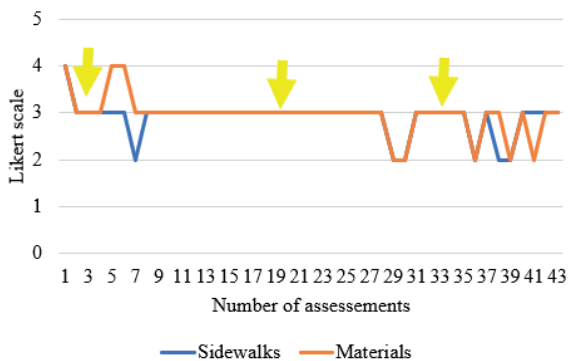
Graph 5. Relationship between the most common defects in hunting and types of materials considered more appropriate

Graph 5 allows us to infer an intimate relationship between the most common defects in hunting and types of materials considered more suitable, as observing the points represented by the yellow arrows, the scale was considered “good” for the two parameters already mentioned, similar to the results verified by Godoy *et al.* (2023).

Source: Prepared by the authors (2023); Yellow arrows indicate the convergence between common sidewalk defects and types of sidewalk surfacing materials.
